ATTIC AND RIM JOIST RETROFIT STOPS AIR INFILTRATION, CREATES BIG ENERGY SAVINGS

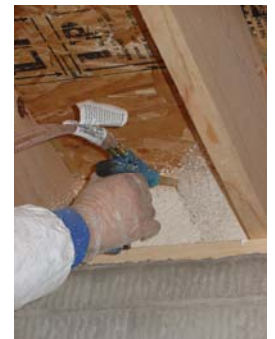
Phase 2: Using the Magnum[™] Heated Hose System, Handi-Foam[®] Spray foam was applied to seal the attic critical seal and thermal bypasses. The critical seal points included pipe penetrations, drywall to wood connections, junction boxes, can lights, soffits, and baffles. A 1" coat of Handi-Foam[®] Spray foam was applied over the entire attic floor to create an airtight critical seal and to stop air infiltration, providing an R-value of 6.2. A blower door test was performed and the air exchanges per day dropped from 13.31 to 9.93 or a 25% decrease, meaning the minimal amount of Handi-Foam[®] Spray foam made a significant difference in preventing air exchanges from entering the house.

Phase 3: Additional insulation was required to meet local building codes' R-value standards. Cellulose was added to the attic and sprayed directly above the foam - a process known as hybrid application. An additional 3" of Handi-Foam[®] Spray Foam was sprayed in the rim joist of the house. A final blower door test was performed and the number of air exchanges dropped to 9.05, which from the start of the project lowered air exchanges by an astounding 32%.
